LAKE COUNTY, ILLINOIS

2012 DIAMOND LAKE SUMMARY REPORT

PREPARED BY THE
LAKE COUNTY HEALTH DEPARTMENT
Population Health Environmental Services

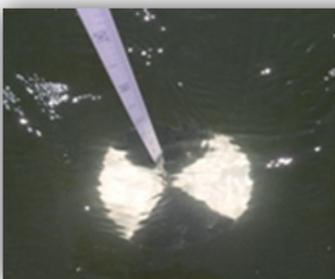
A Secchi disk is an eight-inch diameter weighted metal plate painted black and white in alternating quadrants. A calibrated rope is used to lower the disc into the water and measure the depth to which it is visible.

The VLMP was established in 1981 to gather information on Illinois inland lakes, and to provide an educational program for citizens. The primary measurement by volunteers is the Secchi depth (water clarity). Other observations such as water color, suspended algae and sediment, aquatic plants and odor are also recorded. The sampling season is May through October with measurements taken twice a month. In 2012, there were **50 lakes** that participated in Lake County.

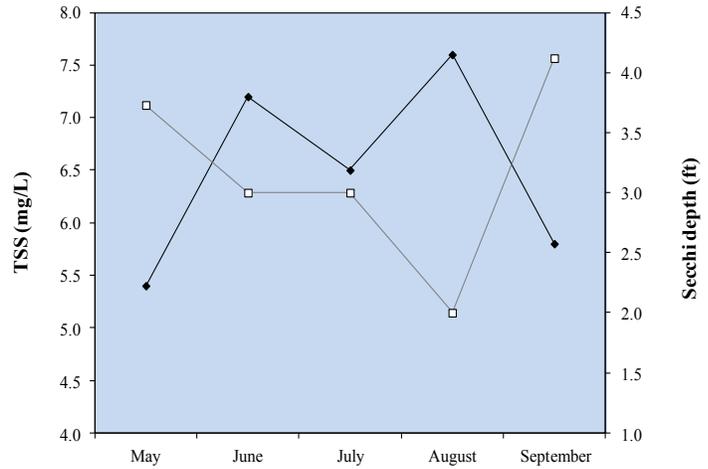
— TSS (mg/L)
 — Secchi Depth (feet)

2012 TSS concentrations averaged 6.5 mg/L which was below the county median of 8.6 mg/L and a 9% increase since the 2002 average concentration of 5.9 mg/L. High TSS values are typically correlated with poor water clarity (Secchi disk depth) and can be detrimental to many aspects of the lake ecosystem including the plant and fish communities.

in 2012 can be attributed to organic particles, such as algae and 48% can be attributed to non-organic particles such as sediment. Turbidity caused by algae and sediment reduced the water clarity in Diamond Lake. The highest TSS concentration occurred in August this corresponded with the lowest Secchi depth of the sampling season of 2.0 feet.

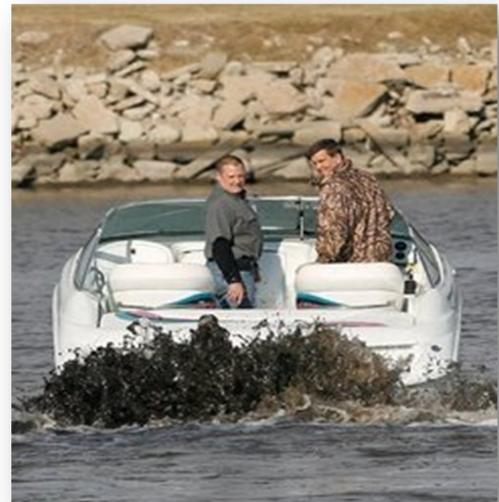
EFFECTIVE MIXING DEPTH

Effective mixing depth is the maximum depth at which the engine stirs up the water and, in turn, the lake bottom sediment. The importance of these findings is that power boating in shallow areas on lake is likely to stir up bottom sediments, decreasing water clarity and releasing nutrients from the lake bottom, which can feed algae and reduce water clarity.

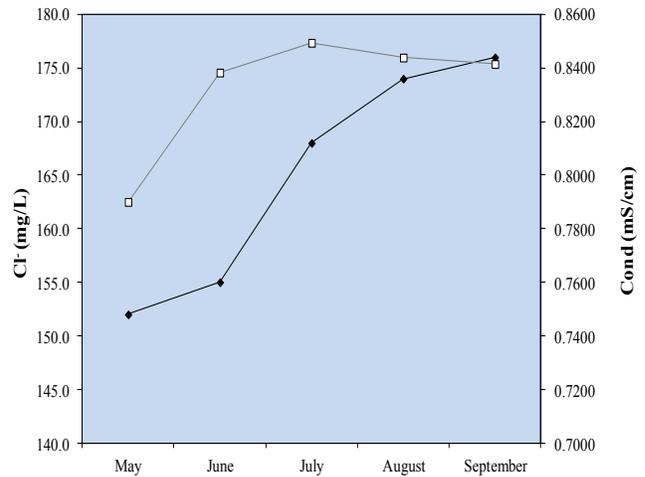
Conductivity (mS/cm) and Chloride (mg/L) concentrations in Diamond Lake, 2012.

tolerant to high chloride concentrations. Diamond Lake 2012 average chloride concentration was 165 mg/L, which is above the county median of 153 mg/L. Typically lakes in the county have experienced increases in chloride concentrations in the past 10 years many doubling in concentrations. The insignificant increase in the 2012 chloride concentration is influenced by the mild winter. Diamond Lake chloride levels are influenced by the winter road maintenance of Illinois Highway 83 and United States Highway 45.

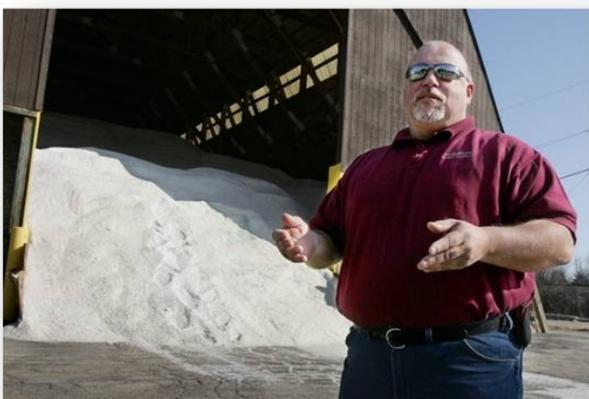
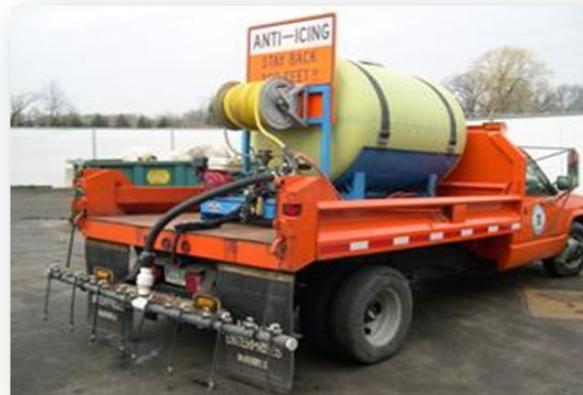
In 2012, Mundelein Public Works Department was left with an overabundance of salt and limited storage for next winter.

Anti-icing truck equipped with spar

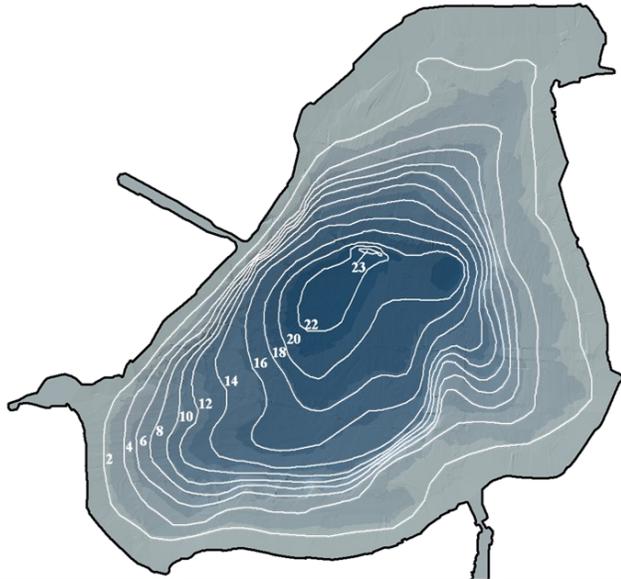
BATHYMETRIC MAP

A bathymetric (depth contour) map is an essential tool for effective lake management since it provides critical information about the

physical features of the lake such as depth, surface area, and volume. This information is particularly important when intensive

management techniques such as chemical treatments for plant or algae control, dredging, fish stocking or habitat enhancement are part of the lake's overall management plan.

In November, 2009 the LCHD-ES collected the field data to replace the bathymetric map created by the LCHD-ES in 1997. Field data was collected using Biosonics equipment along with a Trimble GPS unit with sub-foot accuracy. Once collected, the data was analyzed and imported into ArcGIS for further analysis. In ArcGIS, the contours were drawn and the volume was calculated.

anoxic boundary ranged from 16 feet (June) to 18 feet (July and August). This represents 3.6% to 2.4%, respectively, of the lake volume based on the bathymetric map created by the LCHD-ES in 2009.

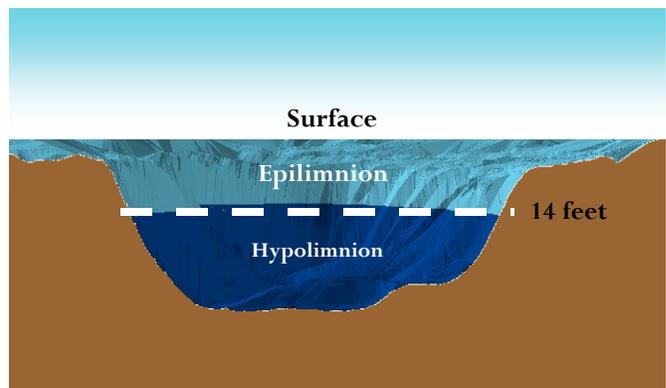
An illustration illustrating the epilimnion and hypolimnion, July, 2012

Diamond Lake was thermally stratified from June through August. Thermal stratification is when a lake divides into an upper, warm water layer (epilimnion) and a lower, cold-water layer (hypolimnion). When stratified, the epilimnetic and hypolimnetic waters do not mix, and the hypolimnion typically experiences anoxic conditions (where dissolved oxygen [DO] concentrations drop below 1 mg/L) by mid-summer. In 2012, Diamond Loon Lake was beginning to stratify in May at 16 feet. By July it was strongly stratified at approximately 14 feet. The

A DO concentration of greater than 5.0 mg/L is recommended to maintain a healthy fishery in a lake. DO concentrations in the epilimnion did not drop below 6.3 mg/L. However, anoxic conditions existed from June through August in the hypolimnion. This is a normal phenomenon in large, deep lakes that stratify. The

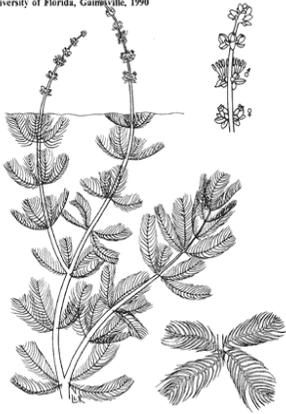
ILLUSTRATION OF EURASIAN WATERMILFOIL

Illustration provided by:
IFAS, Center for Aquatic Plants
University of Florida, Gainesville, 1990

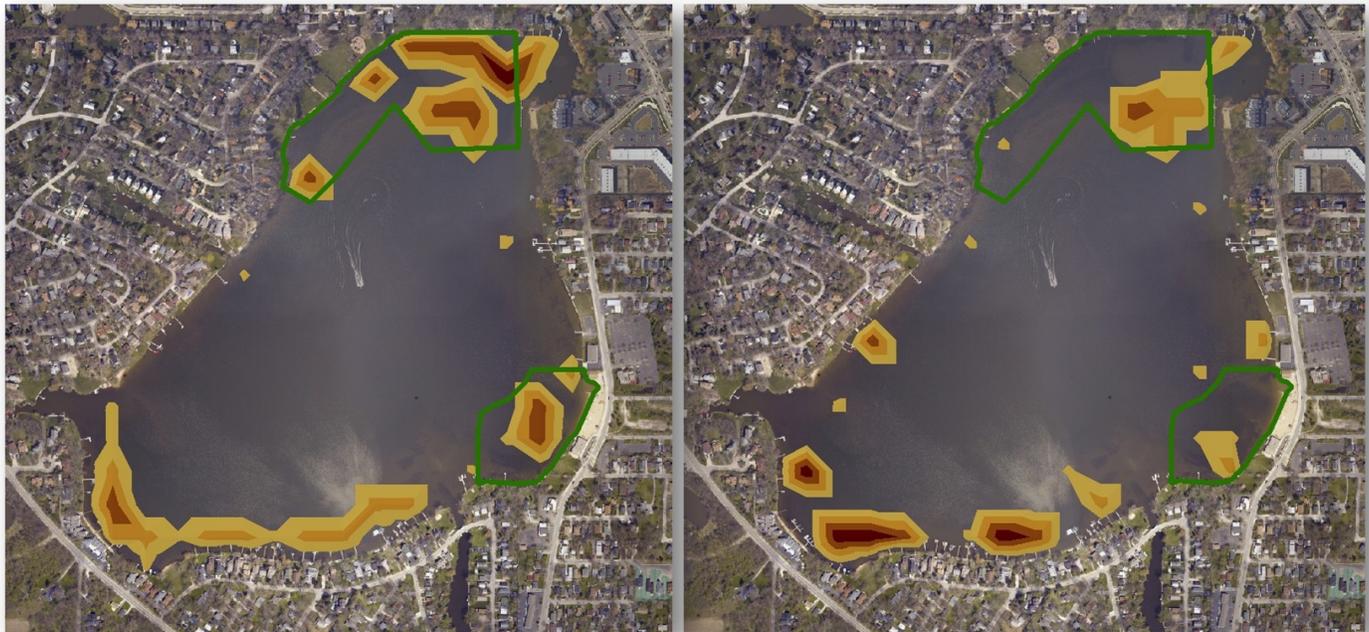
DISTRIBUTION OF EURASIAN WATERMILFOIL DENSITY ACROSS ALL SAMPLES SITES IN APRIL (LEFT) AND JULY (RIGHT) 2012

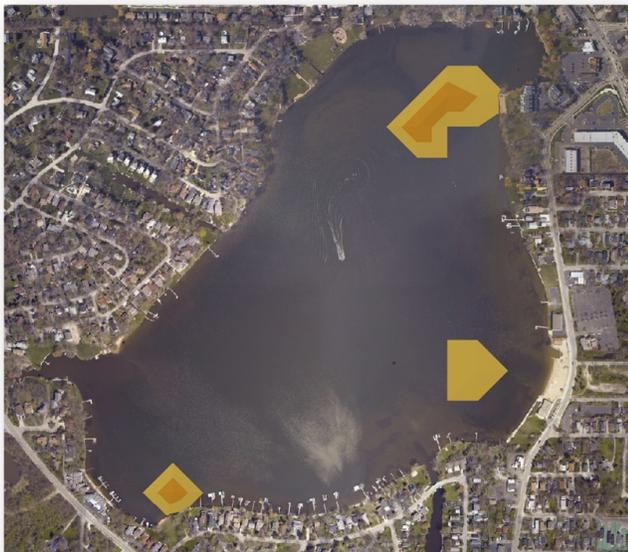
CURLYLEAF PONDWEED DENSITY AT 6 SITES ON DIAMOND LAKE IN JULY 2012,

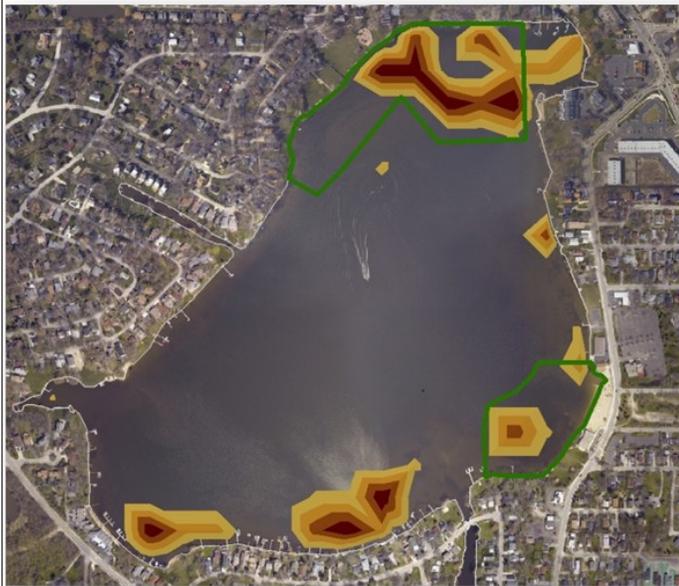
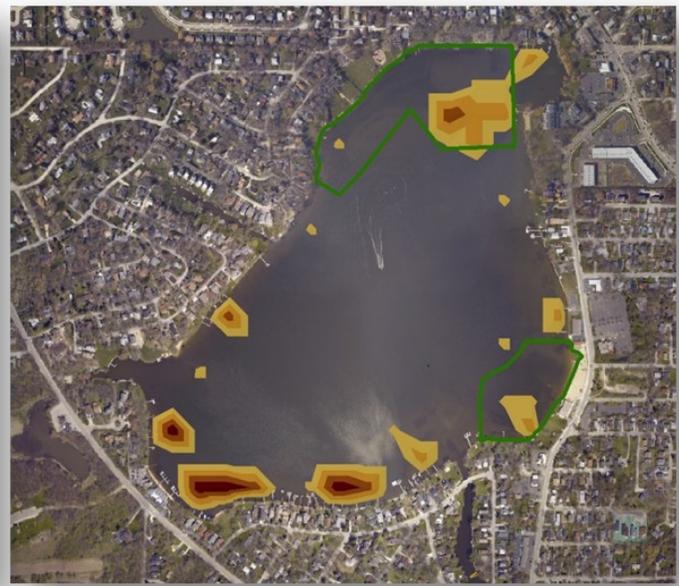
DISTRIBUTION OF EURASIAN WATERMILFOIL DENSITY ACROSS ALL SAMPLES SITES IN JULY 2011 (LEFT) USING A NON-SELECTIVE HERBICIDE AND JULY (RIGHT) 2012 USING A EWM SELECTIVE HERBICIDE

the chemical applications and concentrations have not resulted in a documented reduction in the Eurasian Watermilfoil population. In May 2012 a total of 26 acres were treated with 2,4D to reduce exotic Eurasian Watermilfoil populations. 2, 4D is a relatively fast-acting, systemic, selective herbicide used for the control of Eurasian Watermilfoil and other broad-leaved species. Both the granular and liquid formulations can be effective for spot treatment of Eurasian Watermilfoil. 2,4-D has been shown to be selective to

Eurasian Watermilfoil when used at the labeled rate, leaving native aquatic species relatively unaffected. Coontail is a native plant in Diamond Lake that is also susceptible to 2,4-D. For a healthy aquatic plant community native plant populations need to expand, so special care in the timing of the applications should be considered. This product should be applied while the exotics are actively growing and before our native plants emerge.

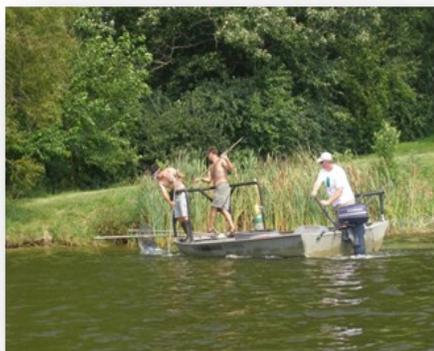
COLLECTION

Illinois Division of Natural Resources Electro-fishing Survey

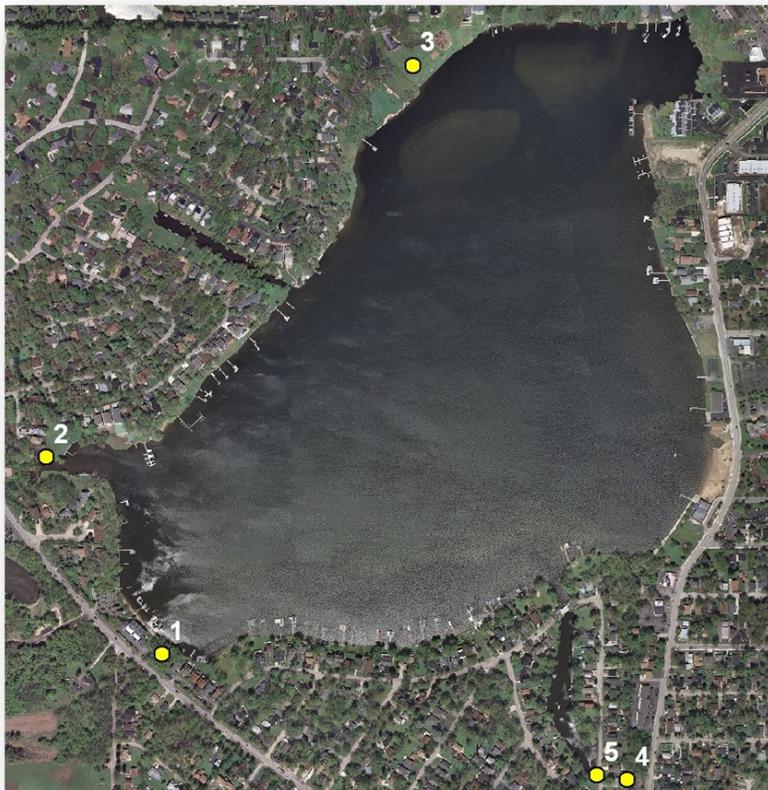
DIAMOND LAKE IMPROVEMENT SITES

Specific improvements were made to these Diamond Lake sites as indicated on the map.

- 1 **Wiech Park streamside restoration** (owned by Mundelein Park and Recreation District)
- 2 **West Shore Park dual rain garden implementation** (owned by West Shore Park Corporation a homeowners association)
- 3 Not completed due to long term site maintenance concerns
- 4 **Hanson Park streamside restoration** (floodplain site is owned by Oak Terrace Homeowners)
- 5 **Oak Terrace roadside buffer rain garden implementation** (site is owned by Fremont Township)

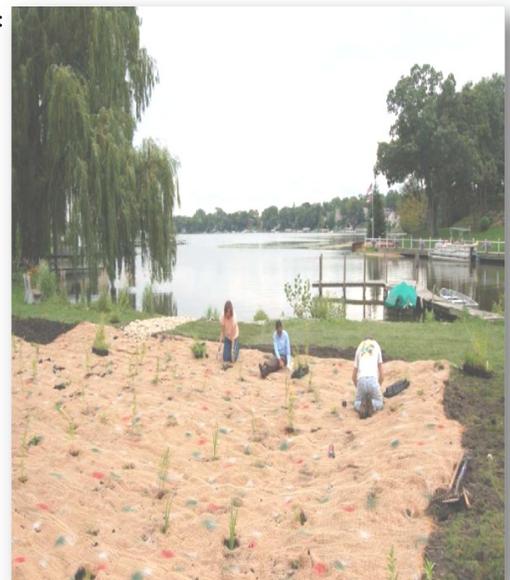
West Shore Park Rain Garden Planting, 2009
